COUVA CHILDREN'S HOSPITAL

GEOTECHNICAL INVESTIGATION REPORT

Prepared by		Checked by		Approved by	
Mr. C Allen		Dr. Derek Gay		Dr. Derek Gay	
Signature	Date	Signature	Date	Signature	Date
1	September 30, 2012	Geotechnical Report		Approval	EISL-412-DD-TR-2012
Rev.	Date	Doc. Description		Issued for	Doc. No.

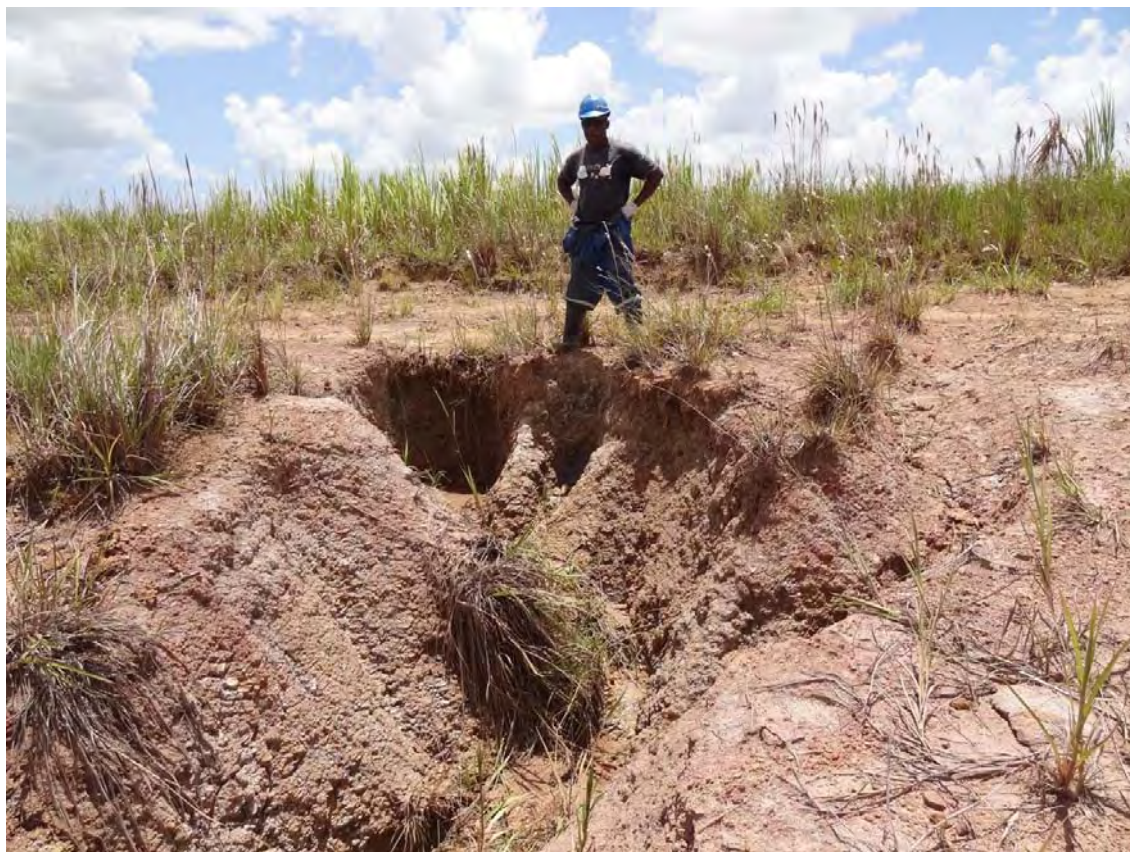
FIGURE 3.4 COUVA CHILDREN'S HOSPITAL, COUVA, TRINIDAD – EROSION CHANNEL
CAUSED BY SURFACE FLOWS.

Surface flows are also considered significant given the observed erosion channels as presented in Figure 3.4. Generally the drainage at the site tends to follow the existing topography.

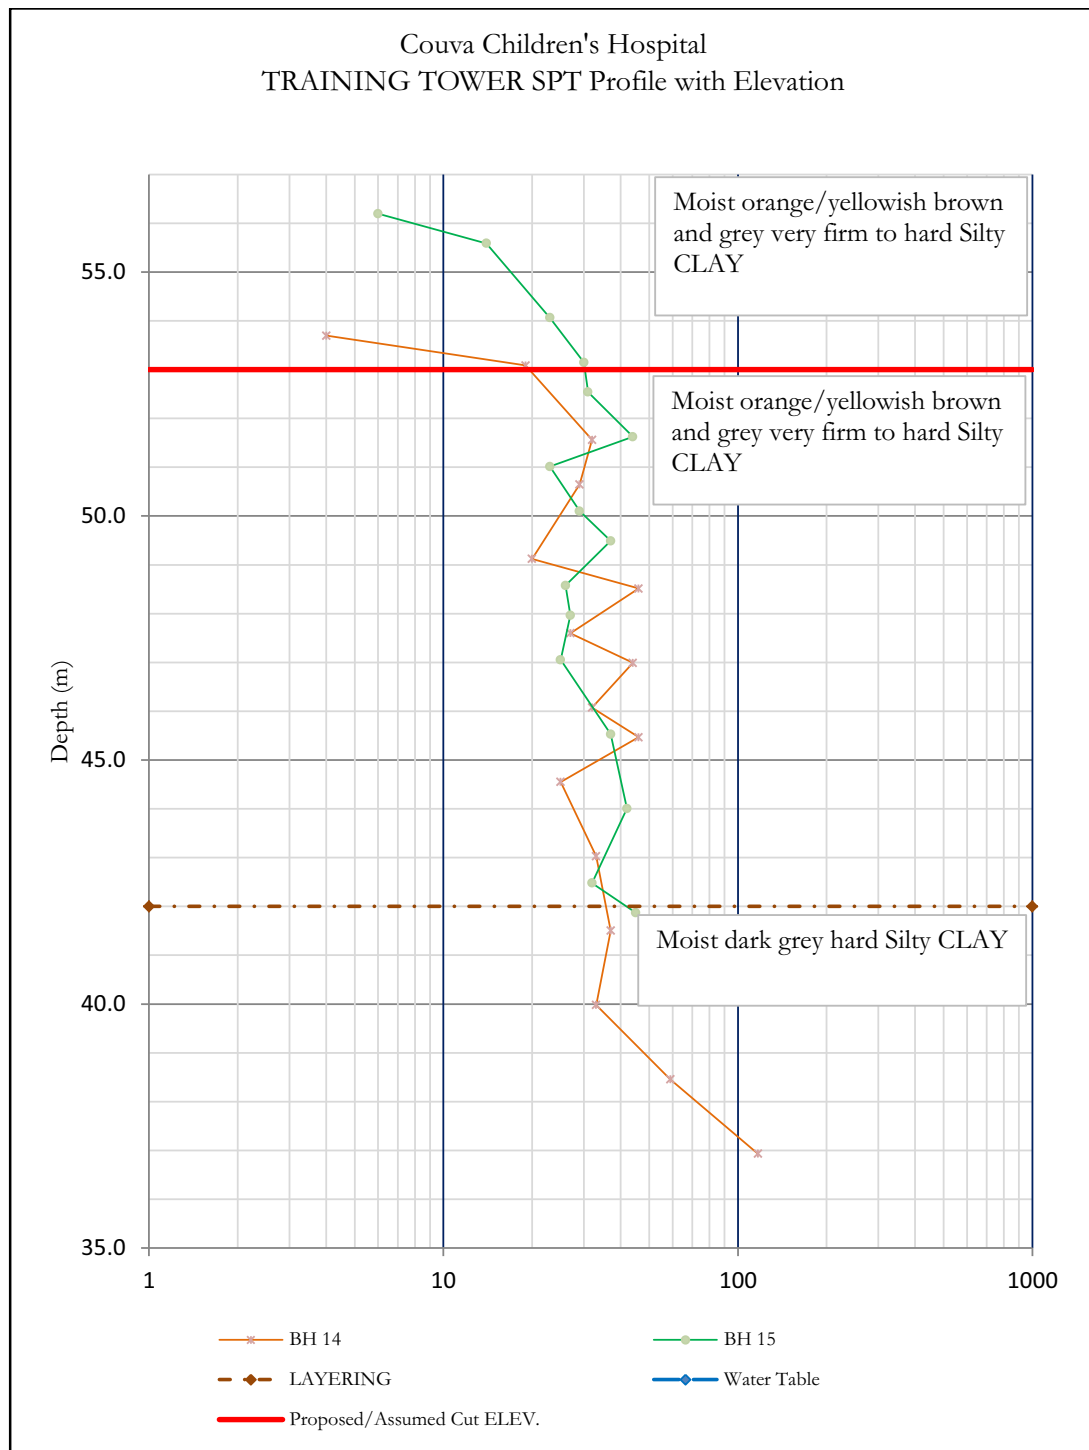
FIGURE 4.2 - COUVA CHILDREN'S HOSPITAL, COUVA, TRINIDAD – SPT VARIATION PROFILE WITH ELEVATION FOR EACH STRUCTURE.

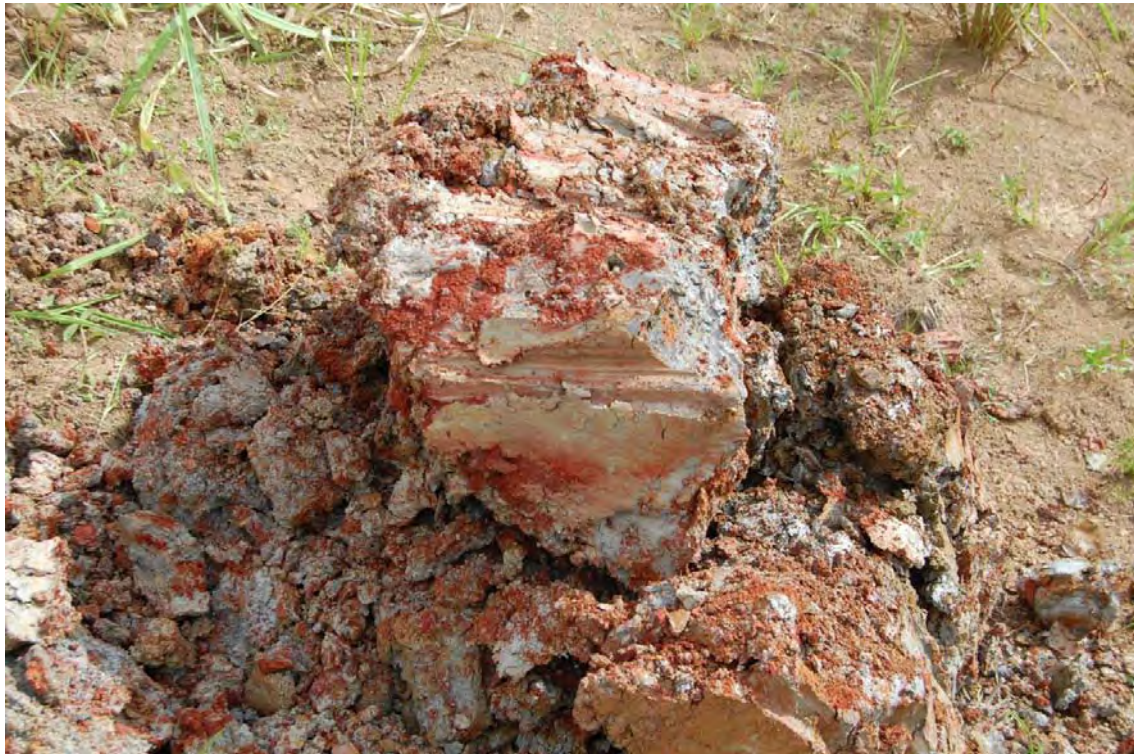
FIGURE. 5.1 - COUVA CHILDREN'S HOSPITAL, COUVA, TRINIDAD – TEST PIT 2 - TOP SOIL OVER MOIST MOTTLED BROWN PLASTIC SILTY CLAYS

Visual and textural identification of the samples retrieved from the boreholes indicates the presence of only fine grain soils. According to the Unified Soil Classification system these soils can be described as loams with varying percentages of Silty Clays (CL-CH) in varying shades of brown and grey (Mottled brown, reddish, orange, light/dark).

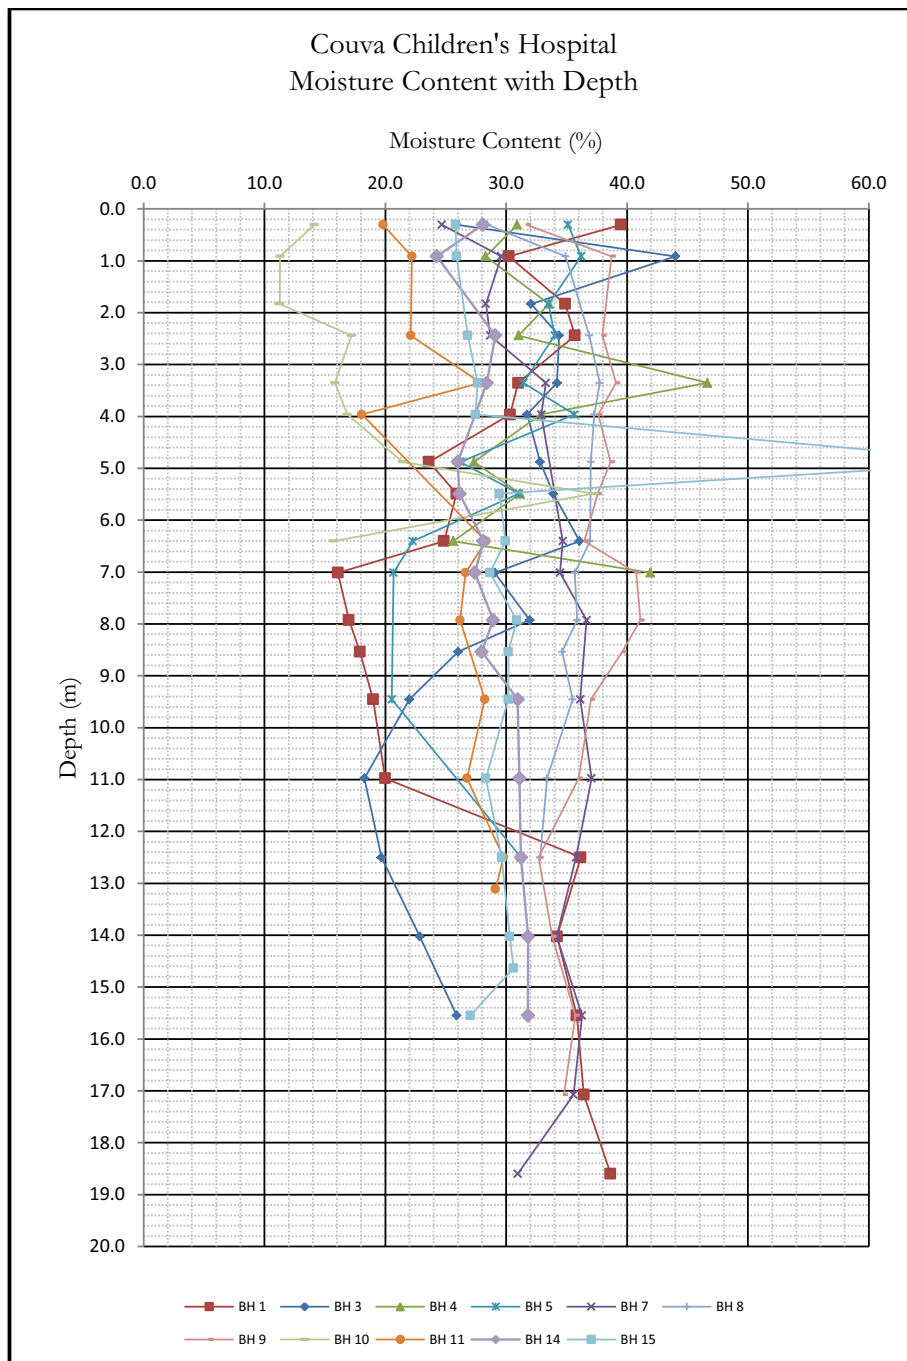
FIGURE. 5.3 - COUVA CHILDREN'S HOSPITAL, COUVA, TRINIDAD – MOISTURE VARIATION WITH DEPTH FOR ALL BORINGS.

The moisture content profiles generated for each borehole is presented in Figure 5.3. Given the large data set it can be observed that moisture contents vary between 28.0 and 40.0 % across the site within the upper 12.0 m. Below 12.0 m, the variation reduces to between 30.0 and 35.0 % approximately. Lower moisture contents as expected can be observed in soils which have slightly higher percentages of sand as in BH1, 3, 10 and 11.

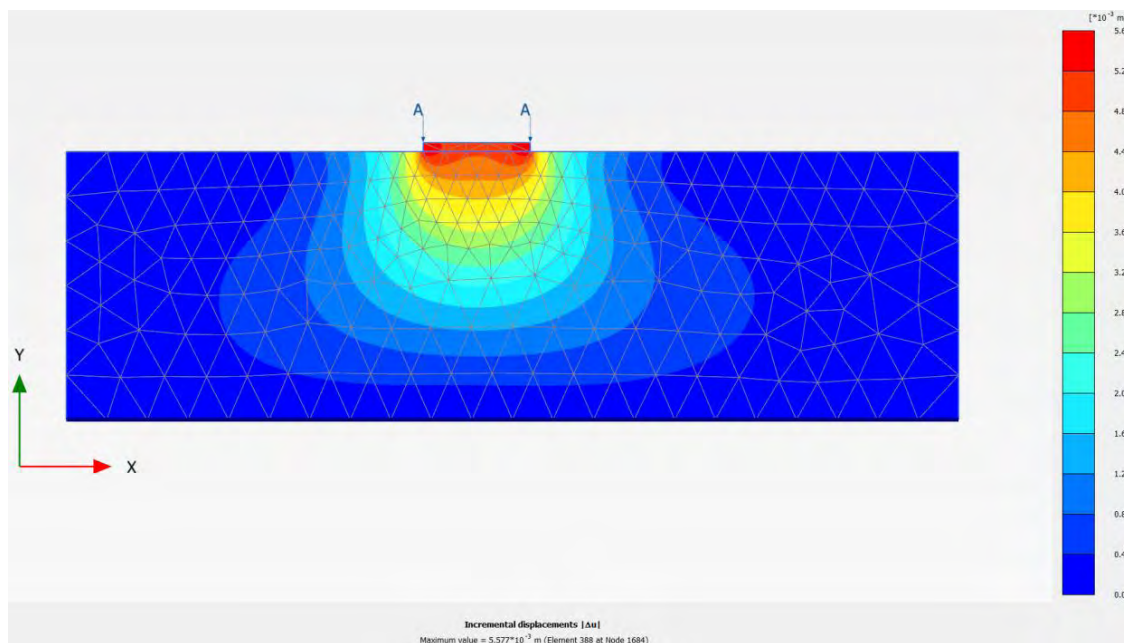
Figure 7.1 Raft Foundation Model, Incremental Displacement output. Maximum Displacement at Foundation Edges = 6 mm

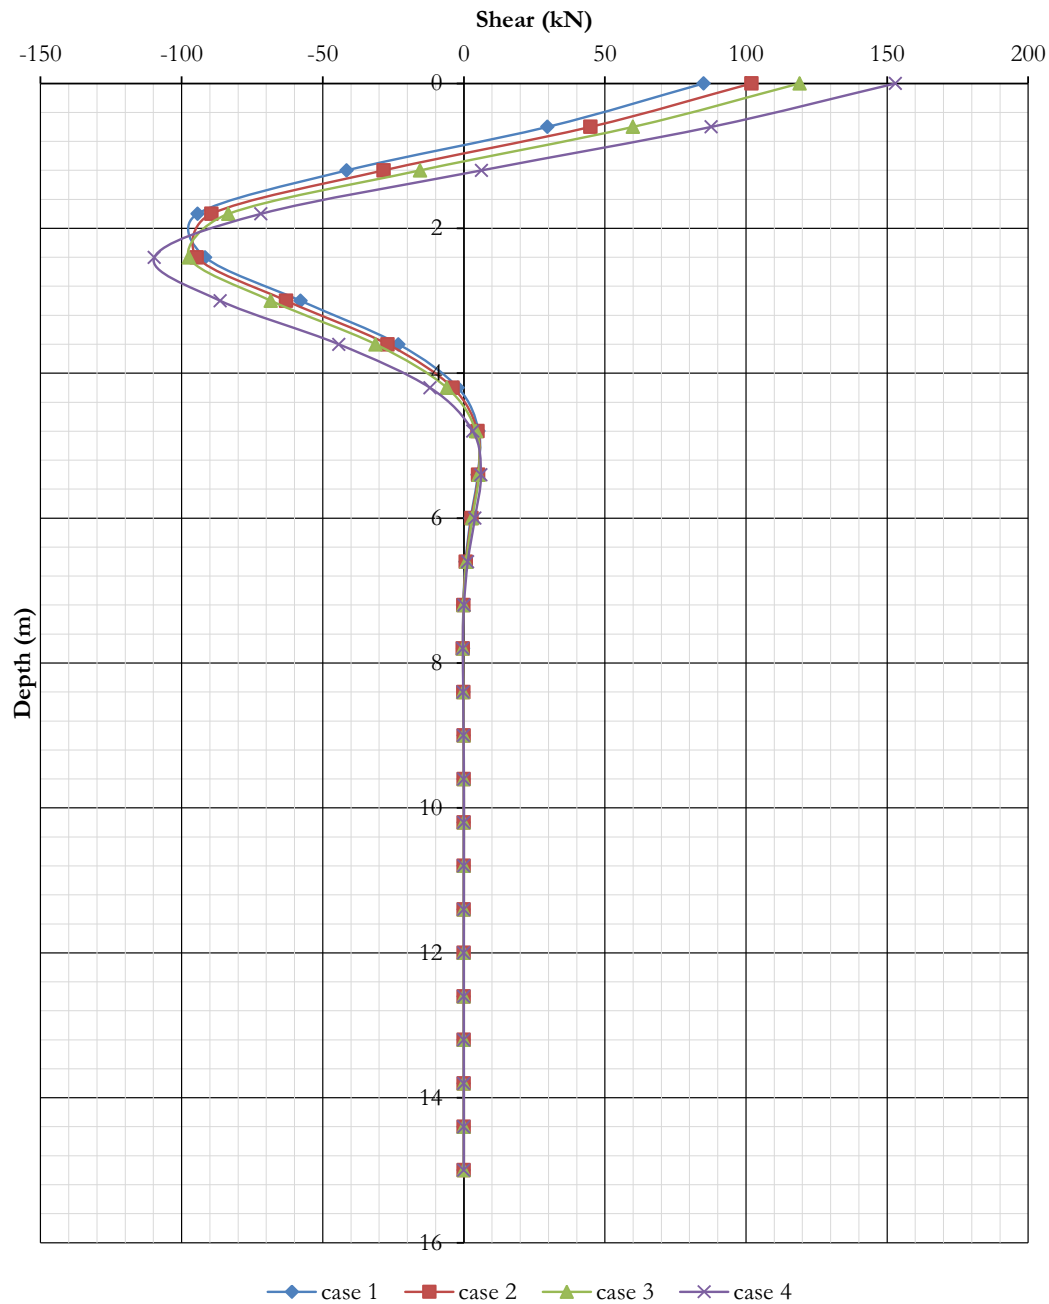
Shear Forces for 450 mm Piles within EIS I, PED, CEP, and Training Centre Tower Profiles

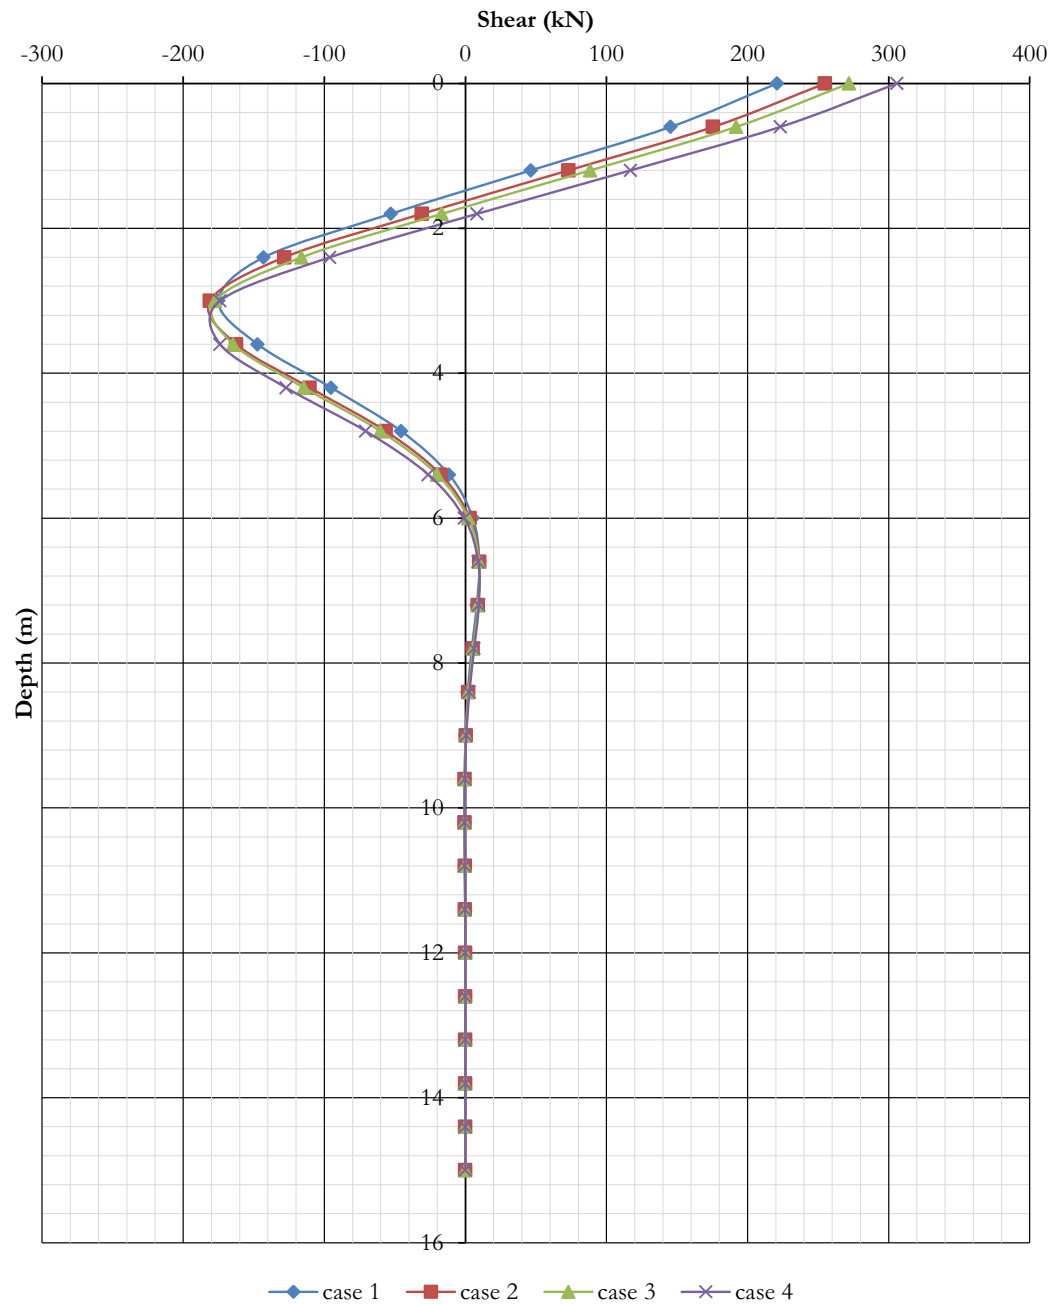
Shear Forces for 600 mm Piles within EIS I, PED, CEP, and Training Centre Tower Profiles

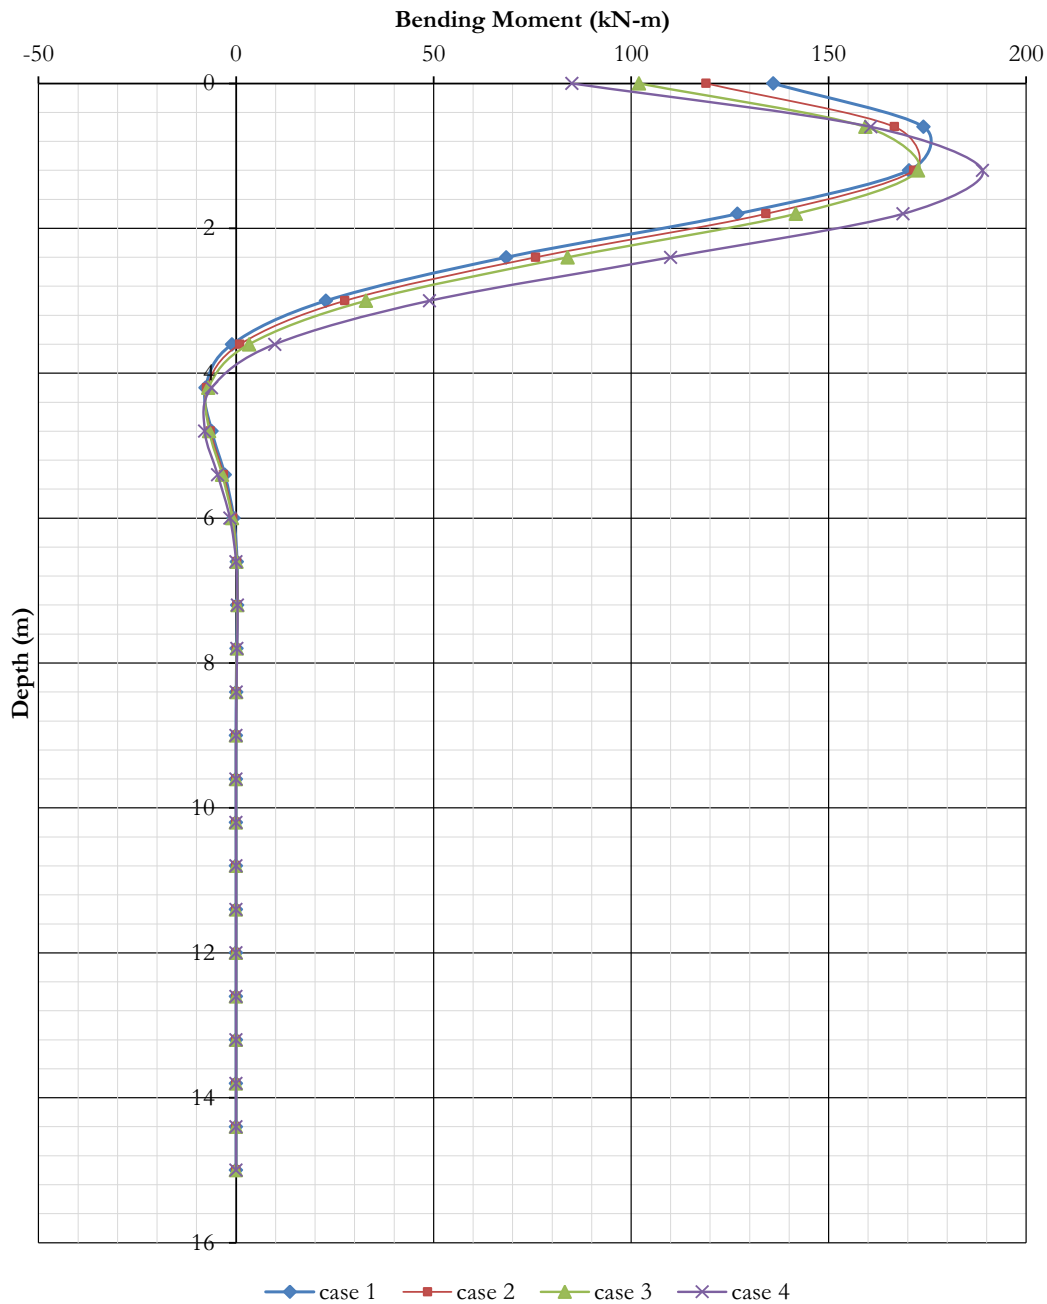
Bending Moments for 450 mm Piles within EIS I, PED, CEP, and Training Centre Tower Profiles

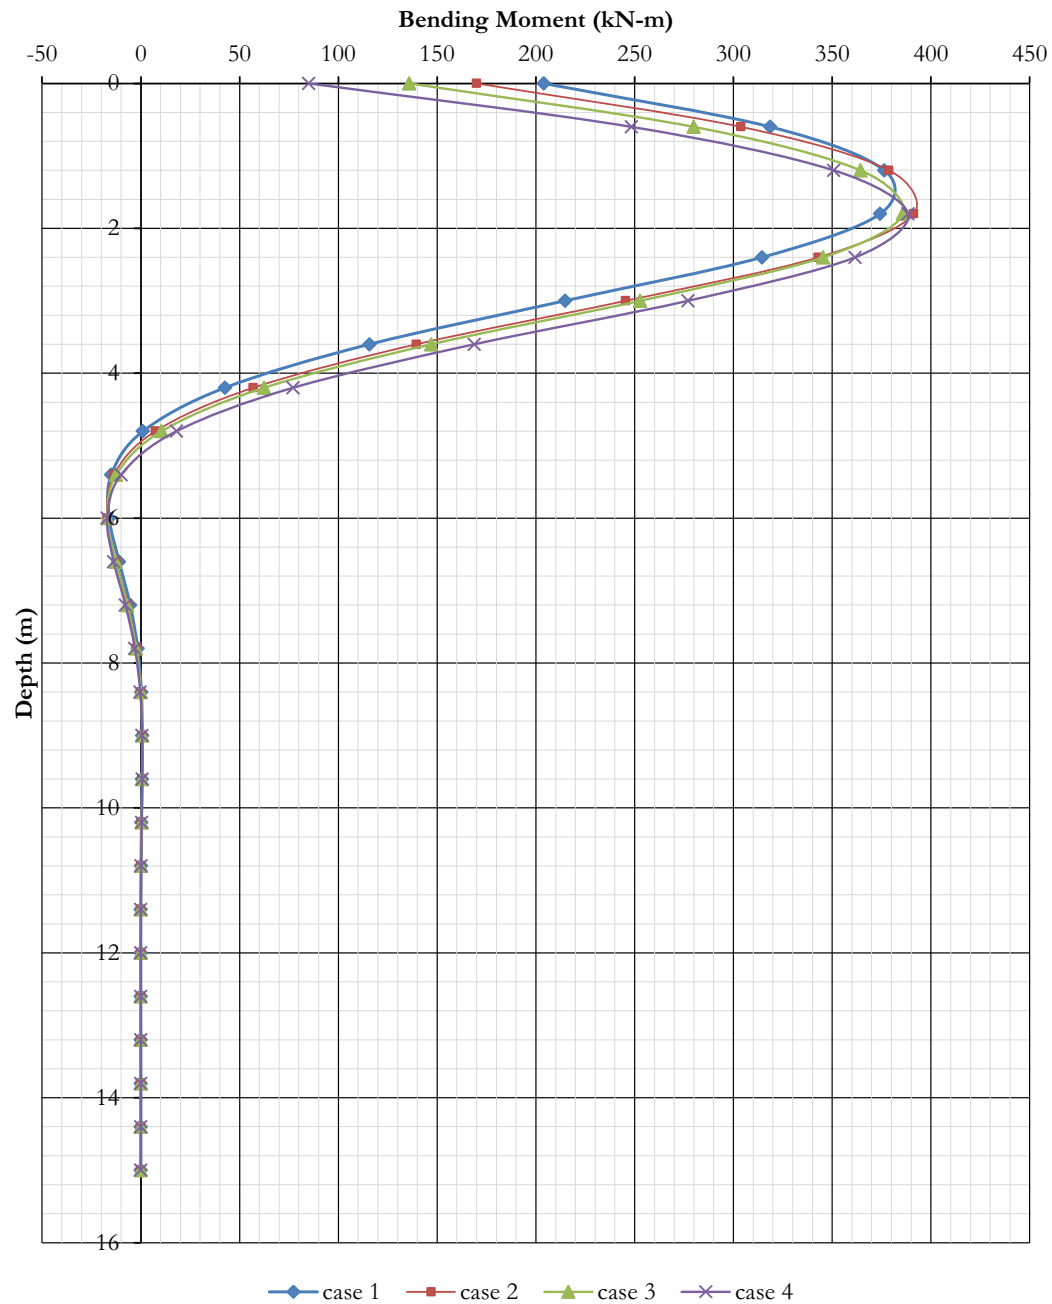
Bending Moments for 600 mm Piles within EIS I, PED, CEP, and Training Centre Tower Profiles

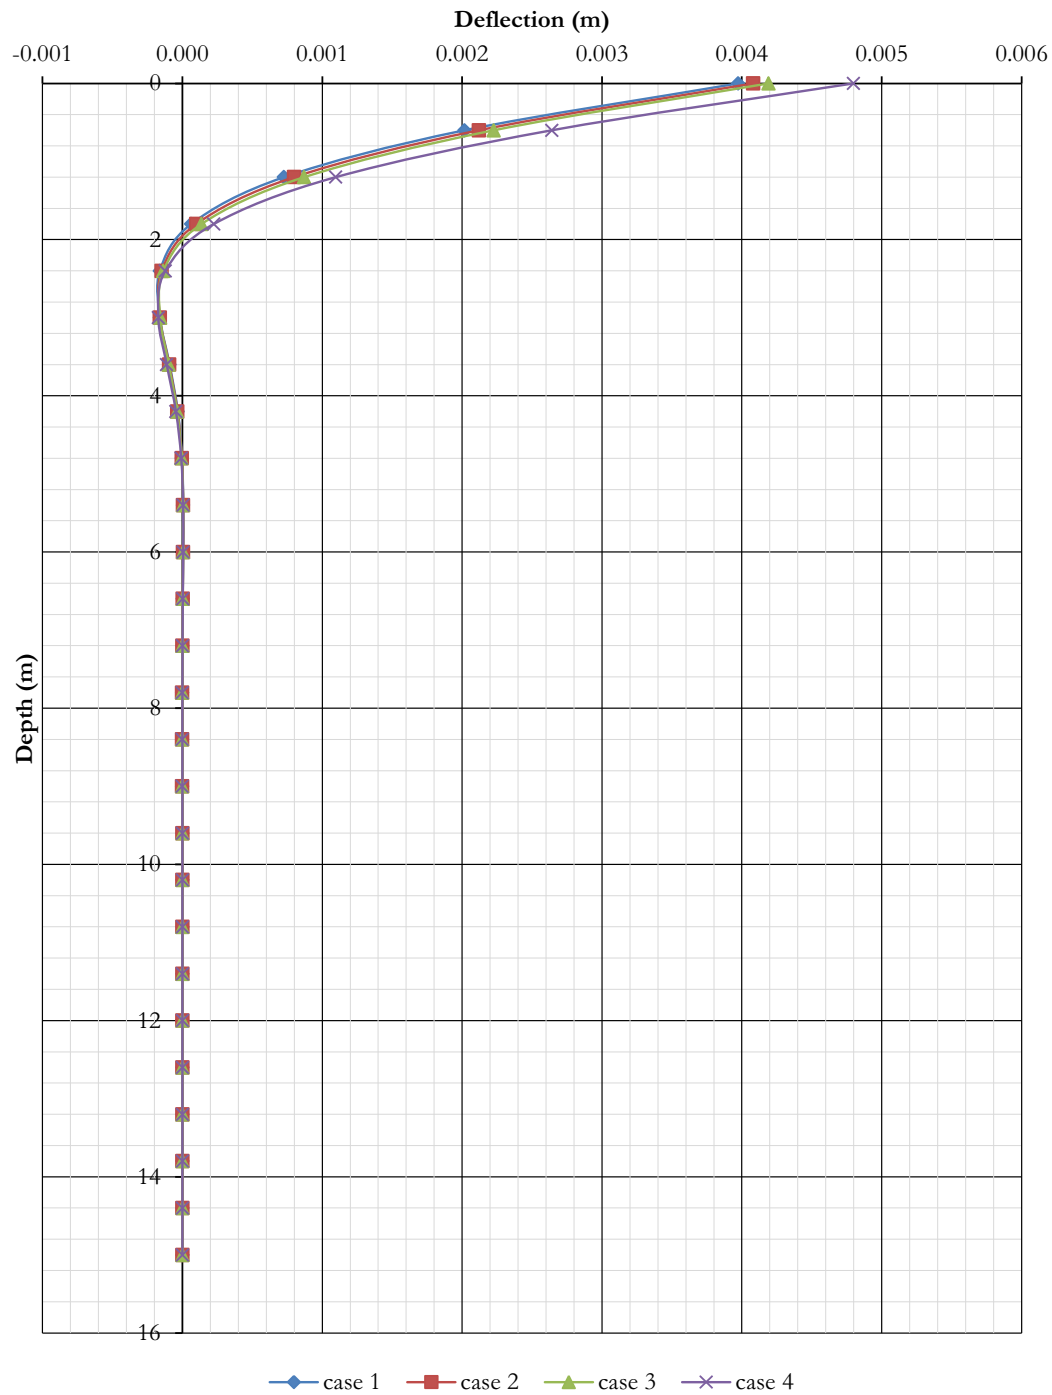
Lateral Deflections for 450 mm Piles within EIS I, PED, CEP, and Training Centre Tower Profiles

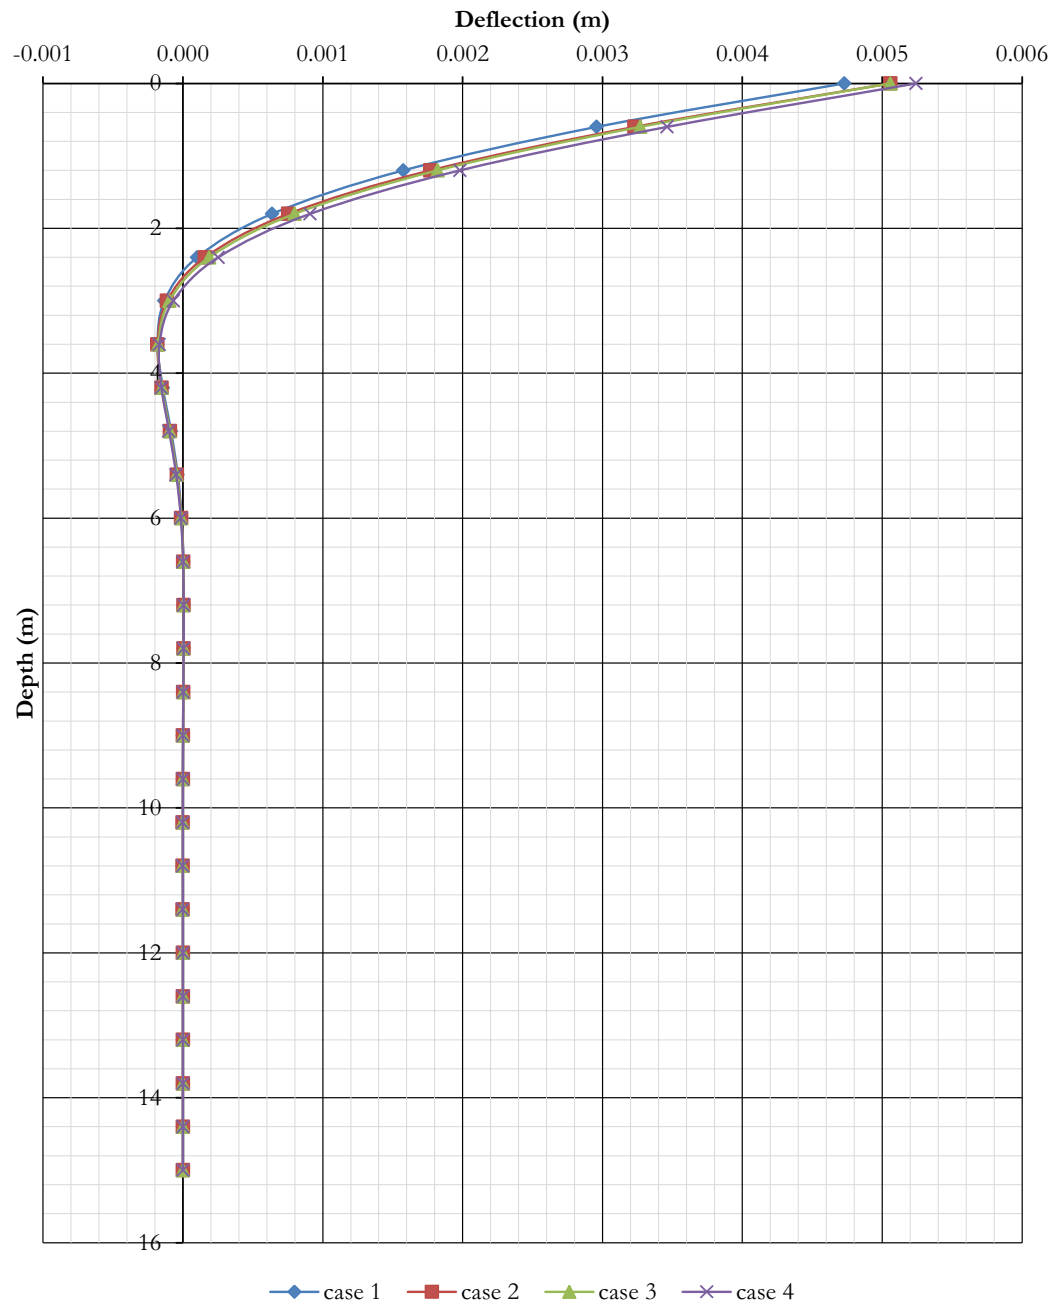
Lateral Deflections for 600 mm Piles within EIS I, PED, CEP, and Training Centre Tower Profiles

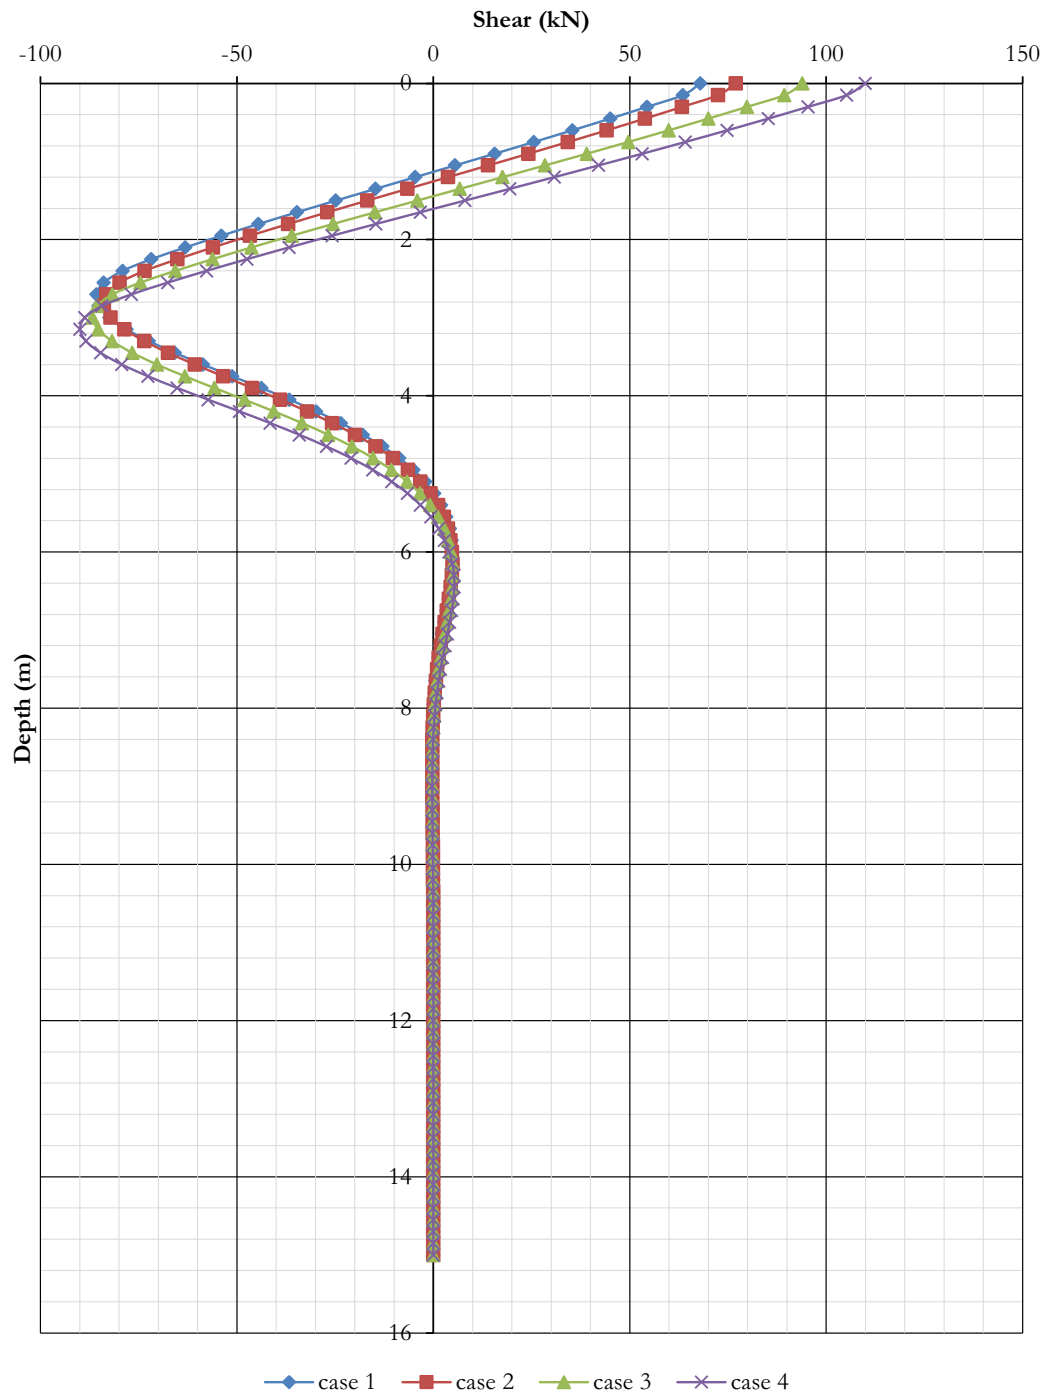
Shear Forces for 450 mm Piles within EIS II and ADULT Tower Profiles

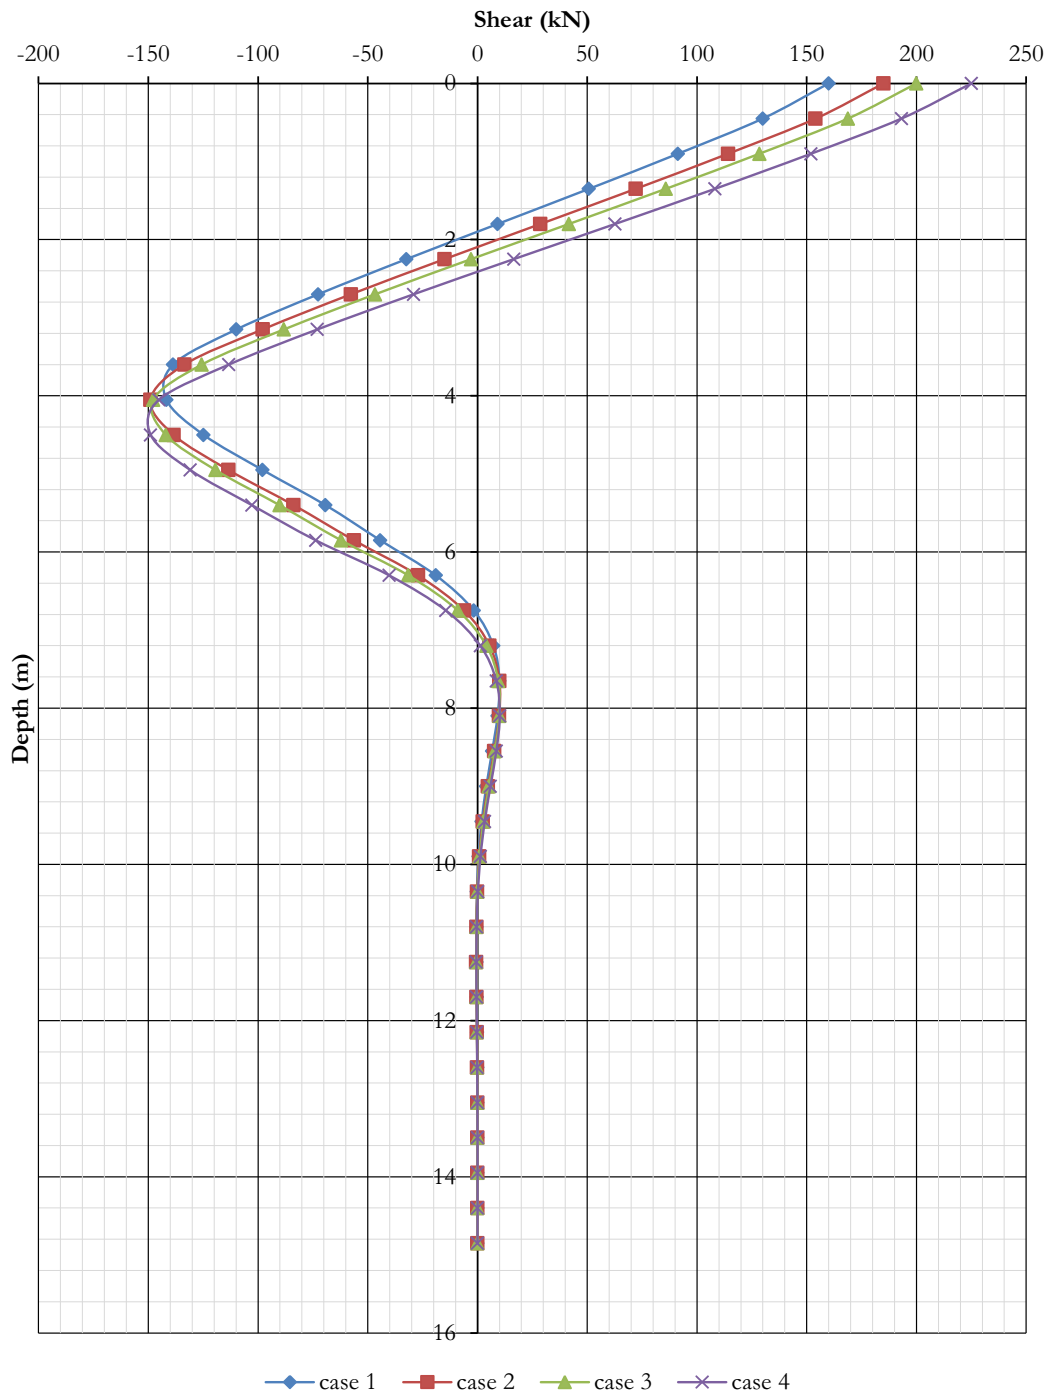
Shear Forces for 600 mm Piles within EIS II and ADULT Tower Profiles

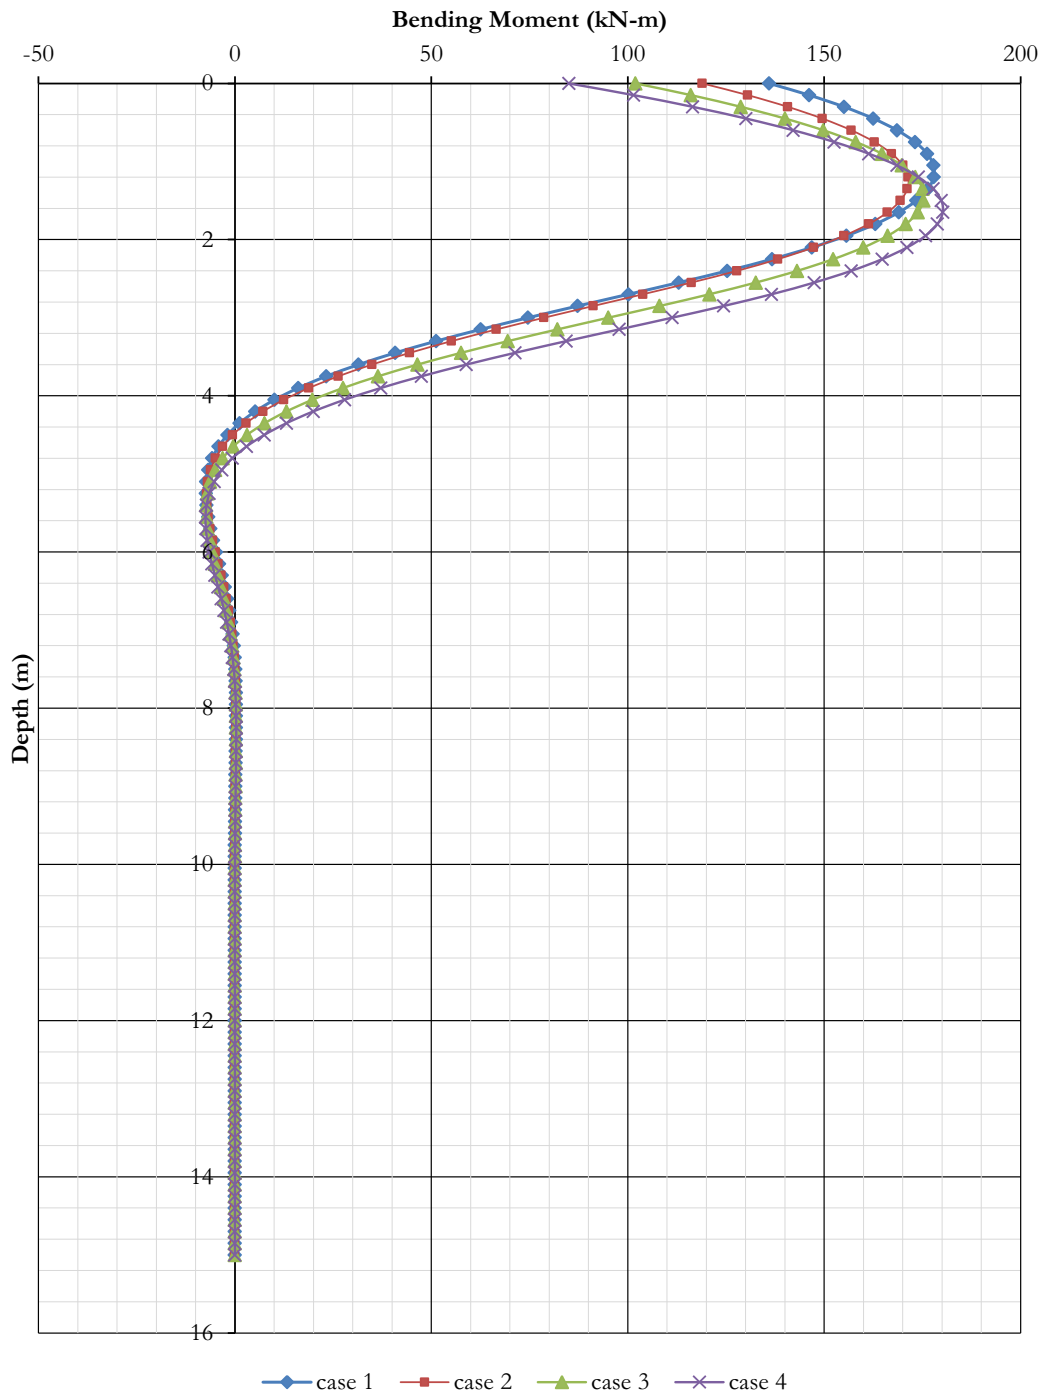
Bending Moments for 450 mm Piles within EIS II and ADULT Tower Profiles

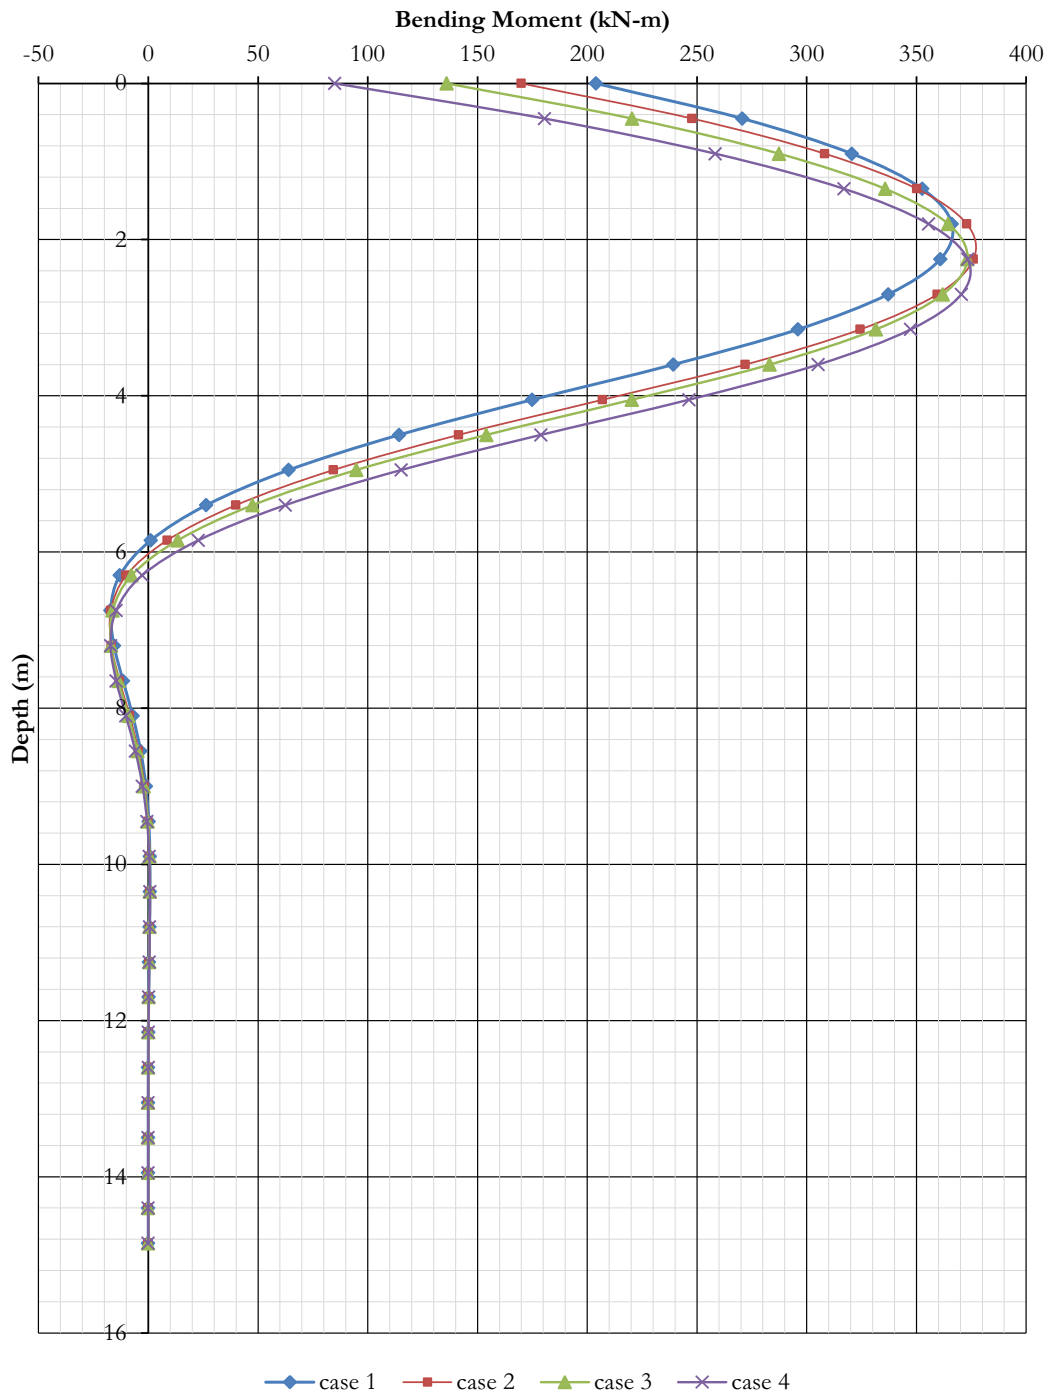
Bending Moments for 600 mm Piles within EIS II and ADULT Tower Profiles

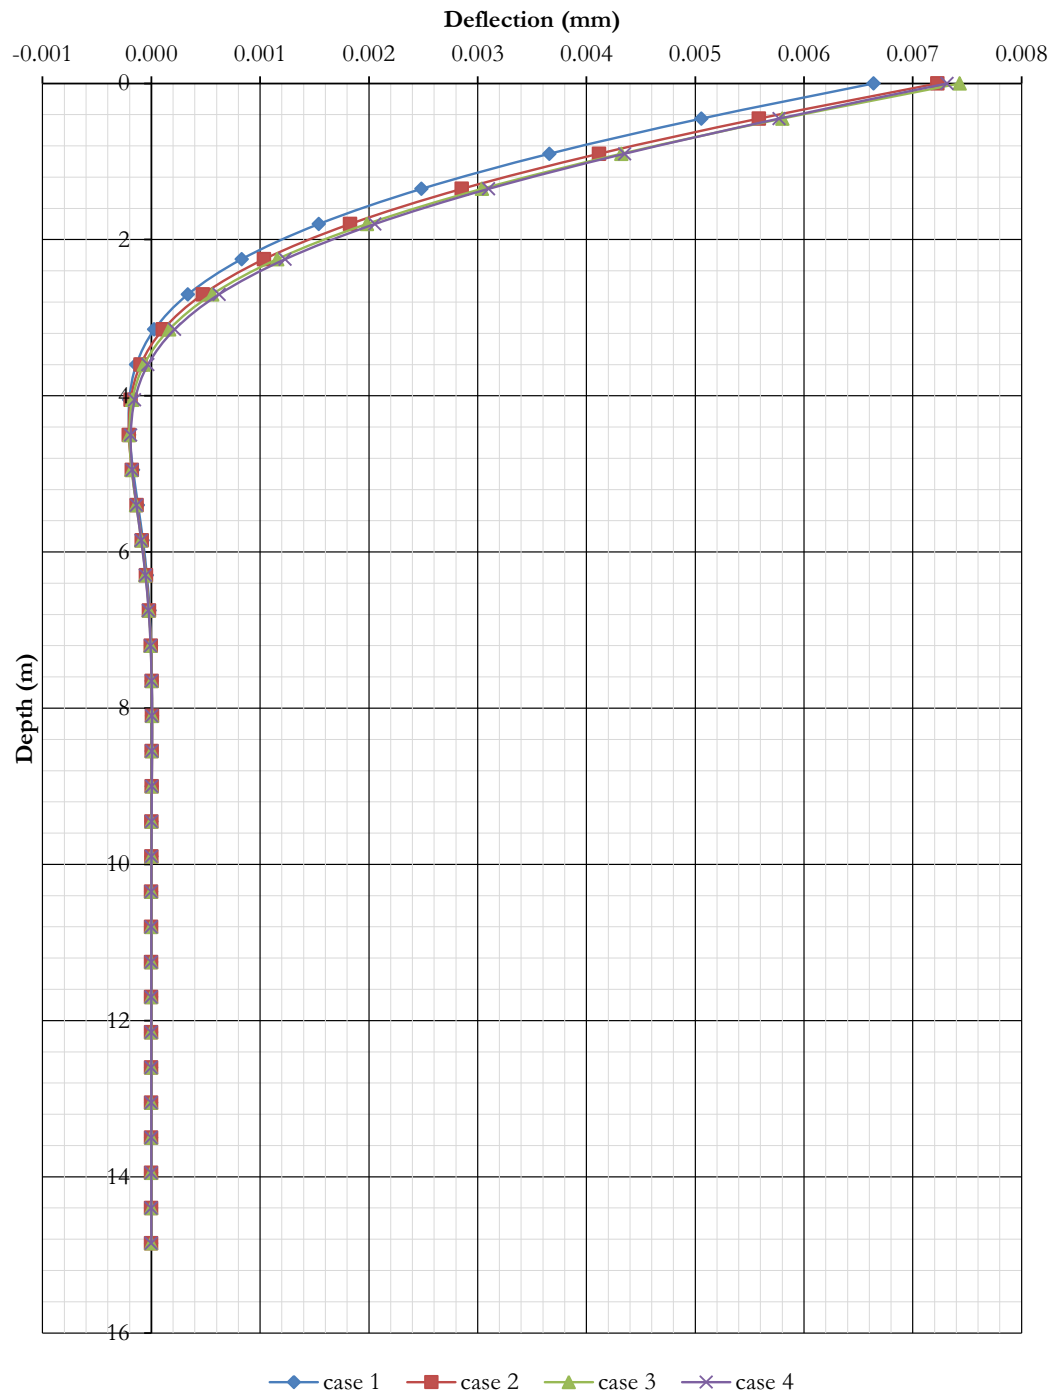
Lateral Deflections for 600 mm Piles within EIS II and ADULT Tower Profiles

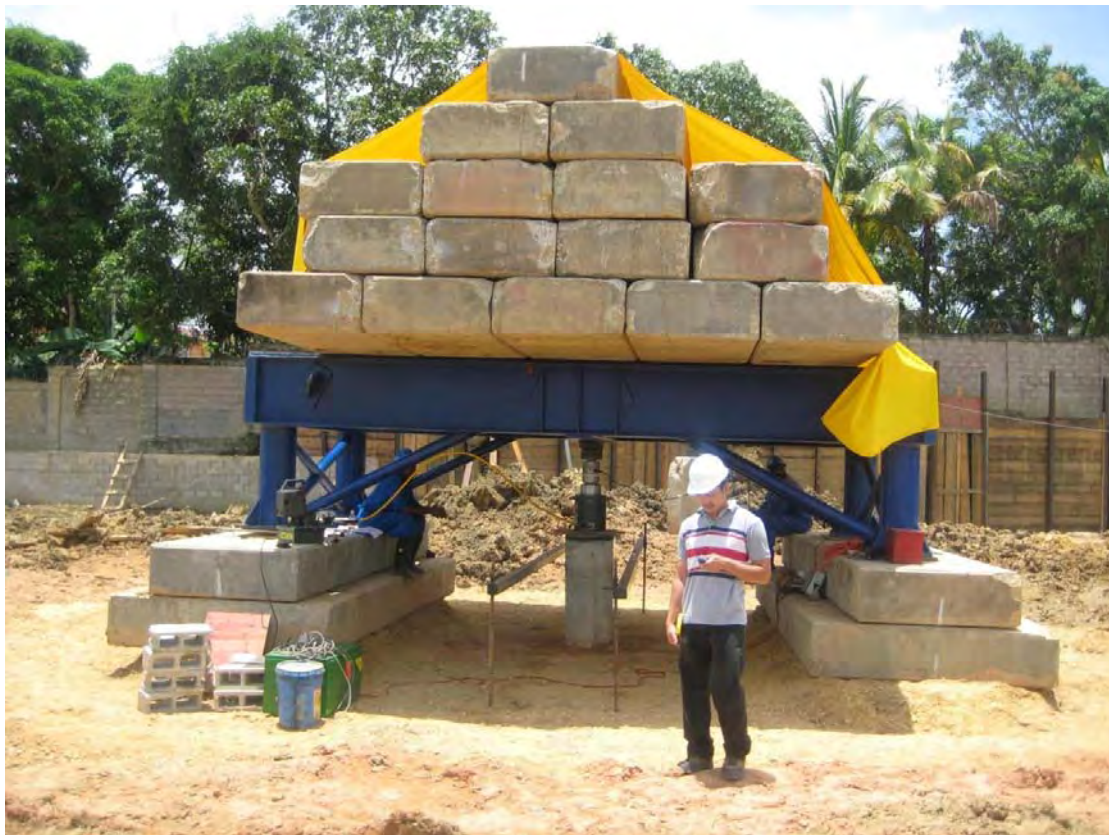
Figure 7.9 - Axial Pile Load test being carried out on a 600 mm CFA Pile (EISL 2010).

Pile testing is a fundamental part of the pile foundation design and is the most effective means of dealing with uncertainties that inevitably arise during design and construction of piles. We therefore recommend that a minimum of one (1) Maintained Load (ML) test be carried out under each structure in accordance with ASTM D1143-81 to a maximum Factor of Safety of 3.0

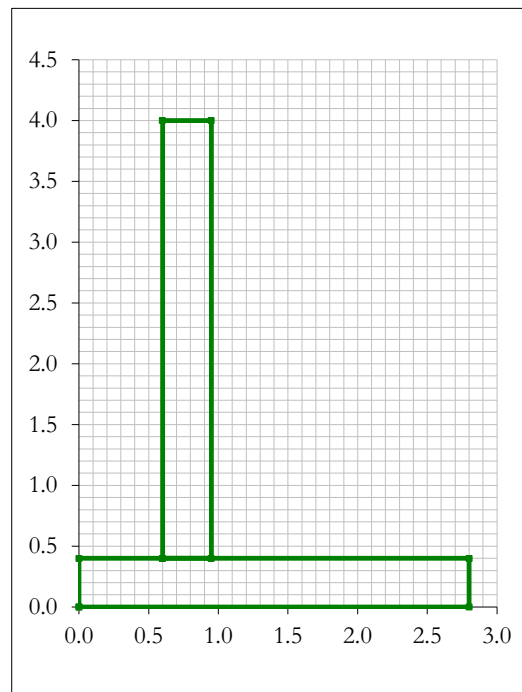
Figure 7.10 Trial wall section

Stability calculations for a 3.5 - 4.0 m high cantilever retaining wall would thus be performed for the soil conditions at the site.
