COUVA CHILDREN'S HOSPITAL

GEOTECHNICAL INVESTIGATION REPORT

Prepared by		Checked by		Approved by	
Mr. C Allen		Dr. Derek Gay		Dr. Derek Gay	
Signature	Date	Signature	Date	Signature	Date
1	September 30, 2012	Geotechnical Report		Approval	EISL-412-DD-TR-2012
Rev.	Date	Doc. Description		Issued for	Doc. No.

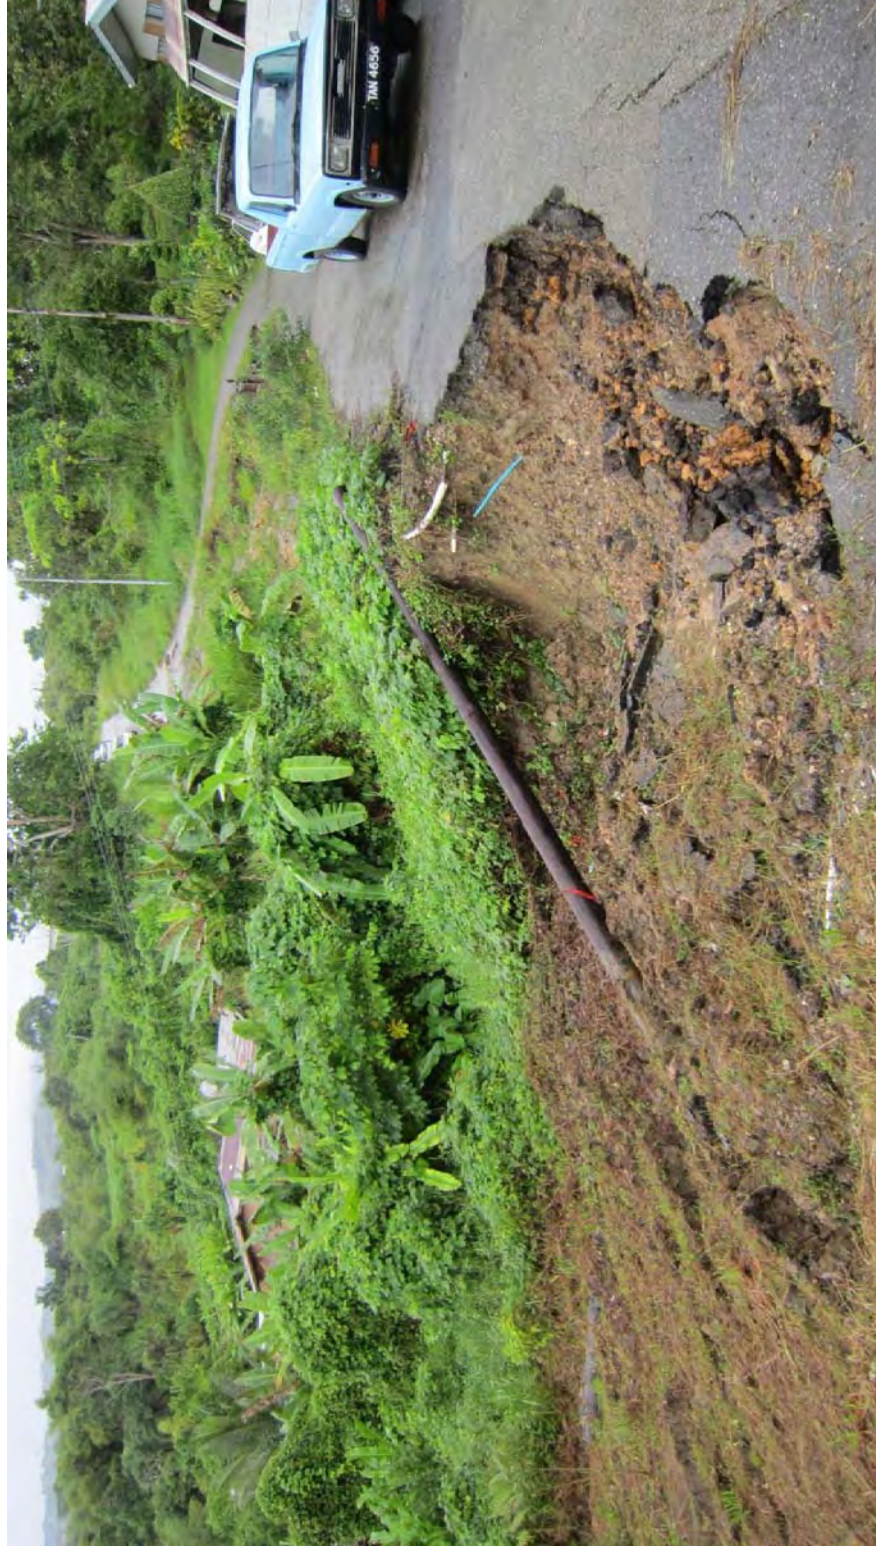
Figure 8.2 Typical Landslide Failure along Secondary Roads in Trinidad caused by leaking water mains.
